# New York State Department of Transportation

## PIA Safety Flag NB2258W007

**BIN: 1065318**

Gowanus Expressway  
2022 Biennial Inspection - Field Sketch

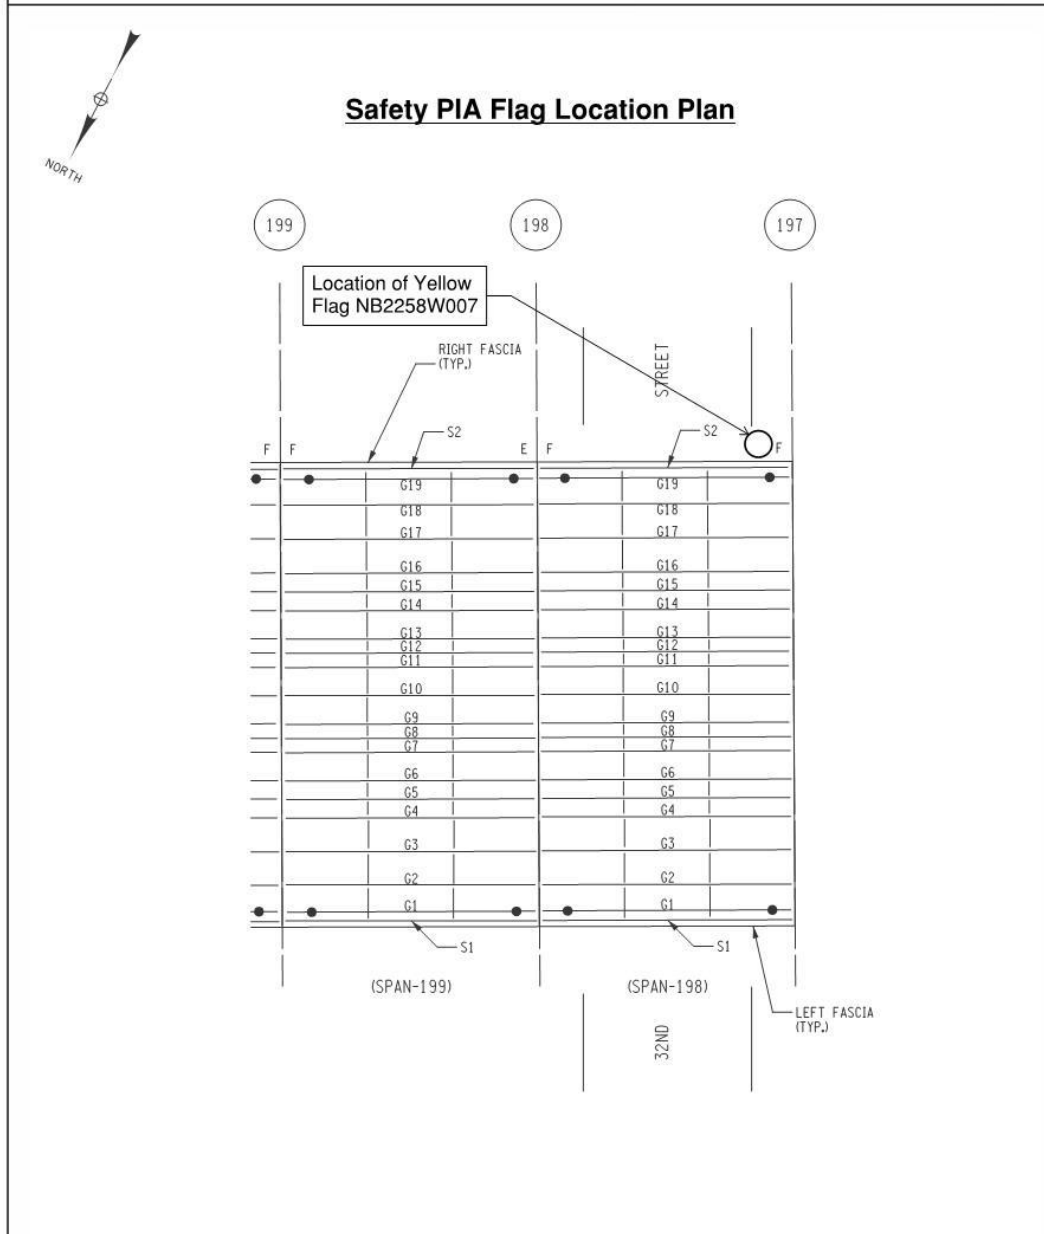
Photo Number: **1**Photo Filename: **22\_Flag Location Plan.jpg**

BIN: 1065318Team: AA/TSDate: 07/27/2022Span: 198Location: Sidewalk adjacent to Pier 197

Attachment Description: Safety PIA Flag Location

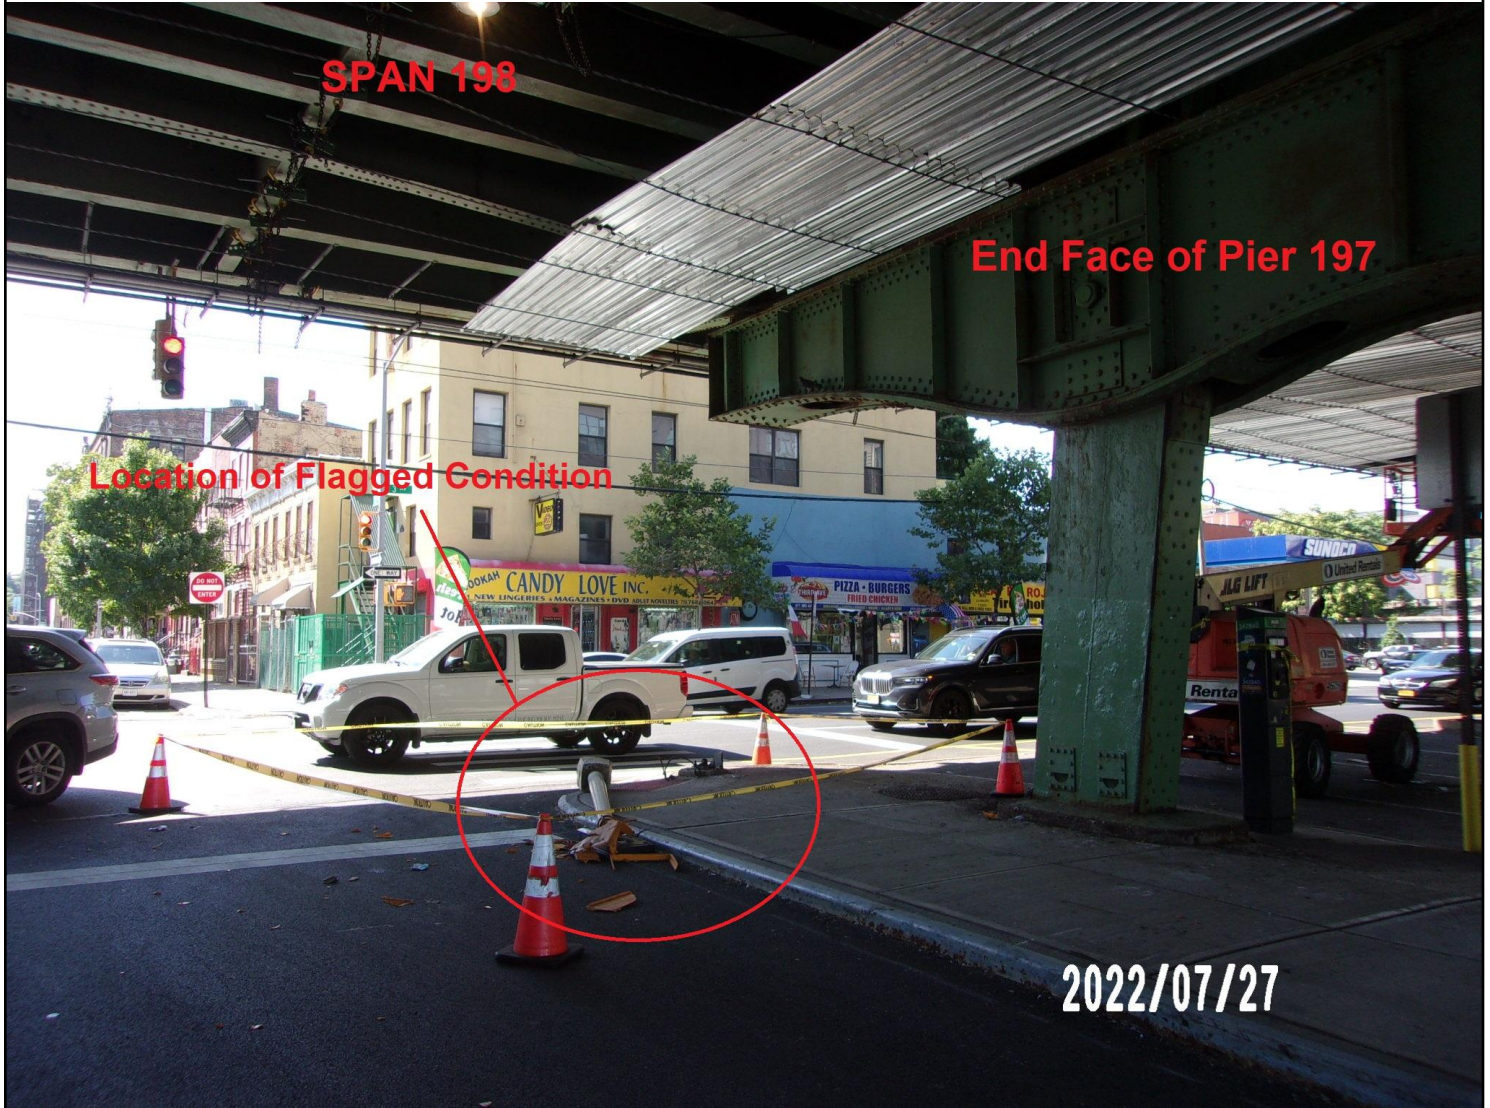
Photo Number: 2

The pedestrian signal pole located on the sidewalk under Span 198 adjacent to the right end of Pier 197 (intersection of 32nd Street and 3rd Avenue EB) is broken at the base resulting in the signal pole laying on the ground. Due to the broken signal pole, there are exposed wires at the base. The signal pole is partially laying in the street. This area is accessible to pedestrians but is currently coned off with yellow caution tape. This is a newly flagged condition.

**Attachment Description:** General view of the flagged condition under Span 198 adjacent to the right end of Pier 197. Looking Begin and Right.

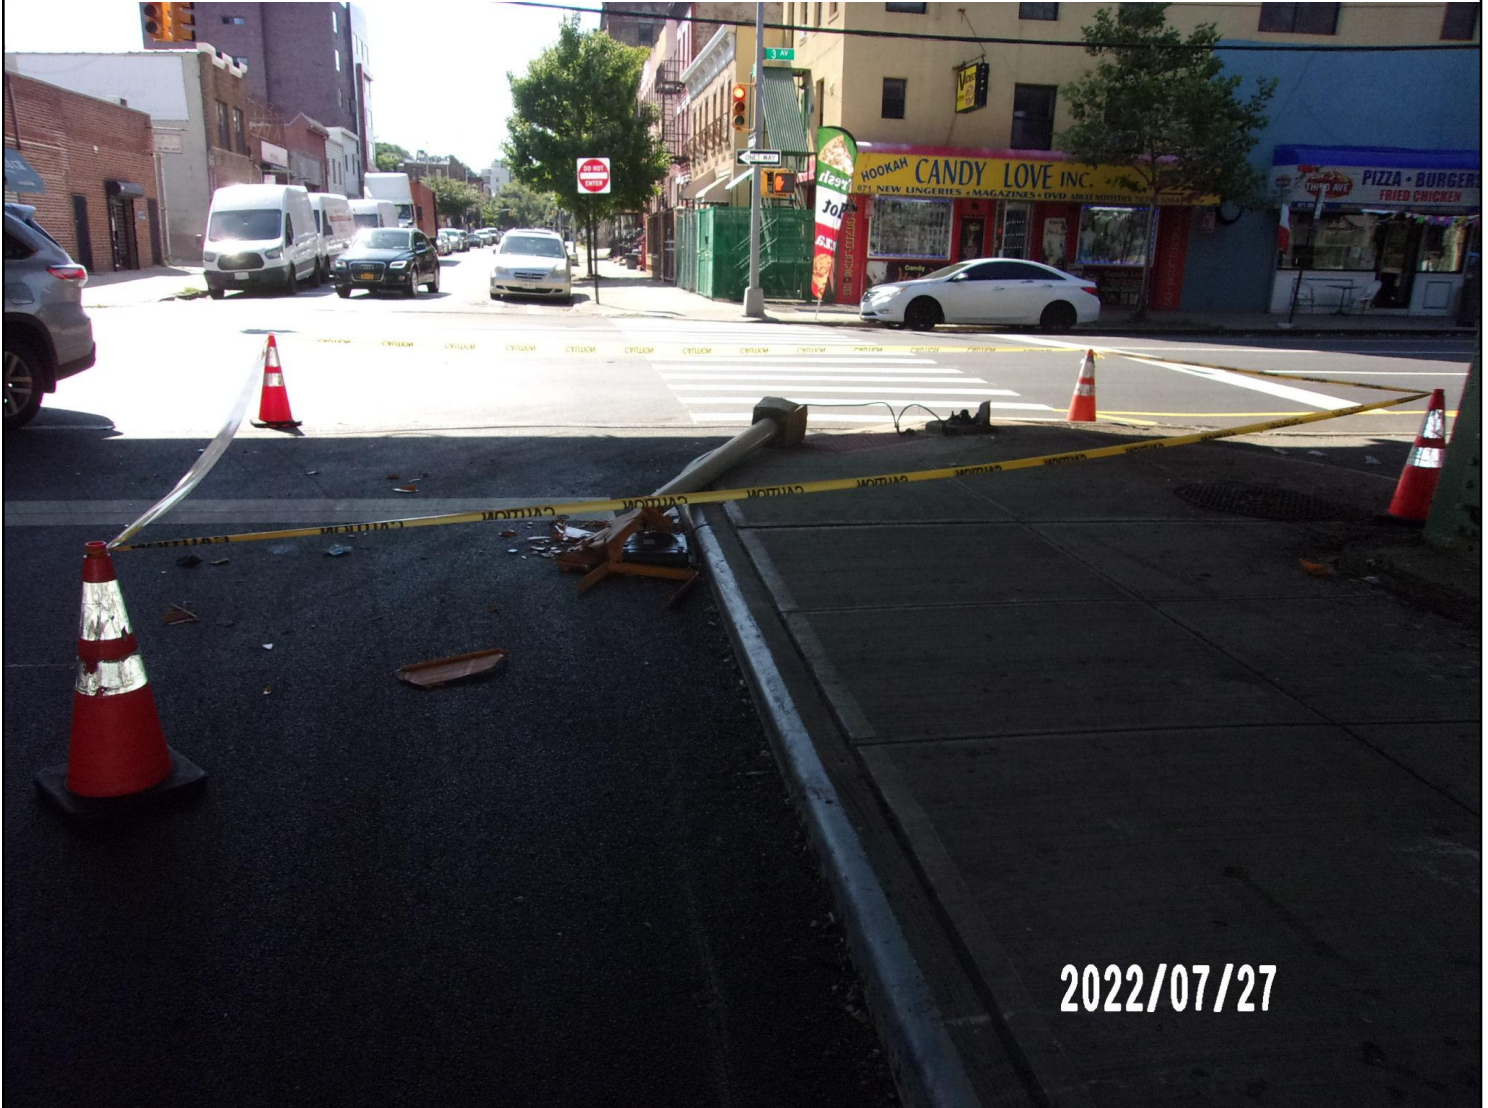
Photo Number: 3

**Attachment Description:** The sidewalk at the right end of Pier 197 under Span 198. The pedestrian signal pole is broken with exposed wires at the base. The area has been coned off with yellow caution tape. Looking Right.

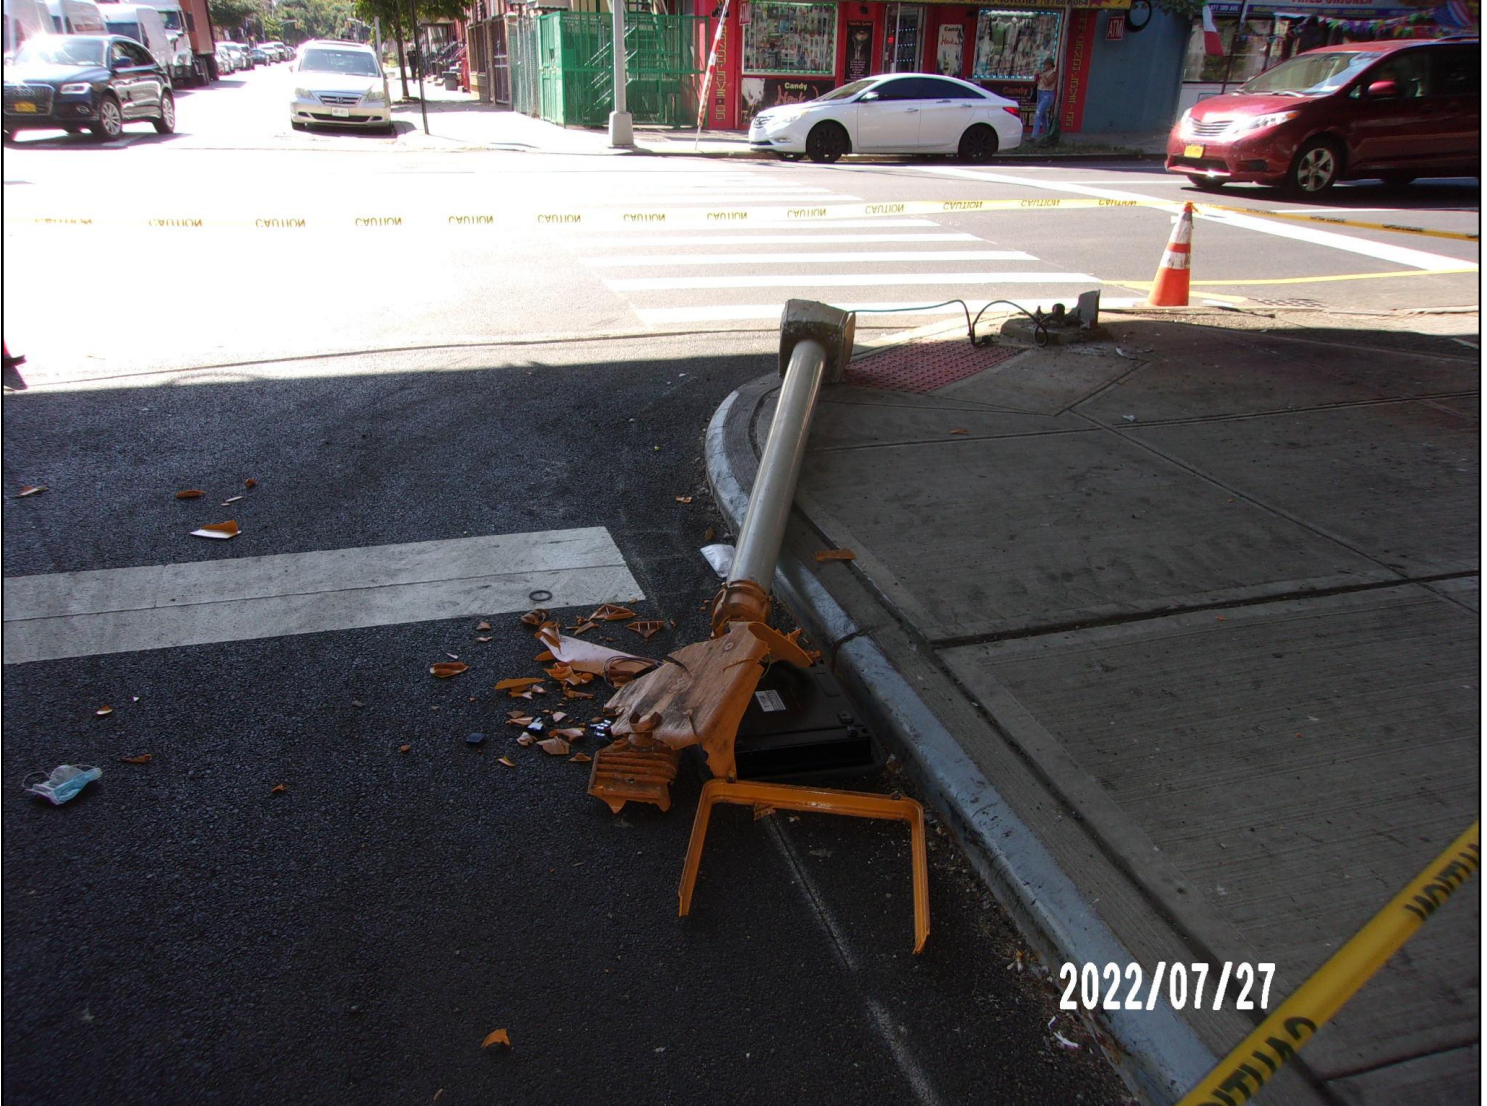
Photo Number: 4

**Attachment Description:** The sidewalk at the right end of Pier 197 under Span 198. The broken signal pole is laying on the ground on top of the sidewalk and partially into the street. Looking Right.

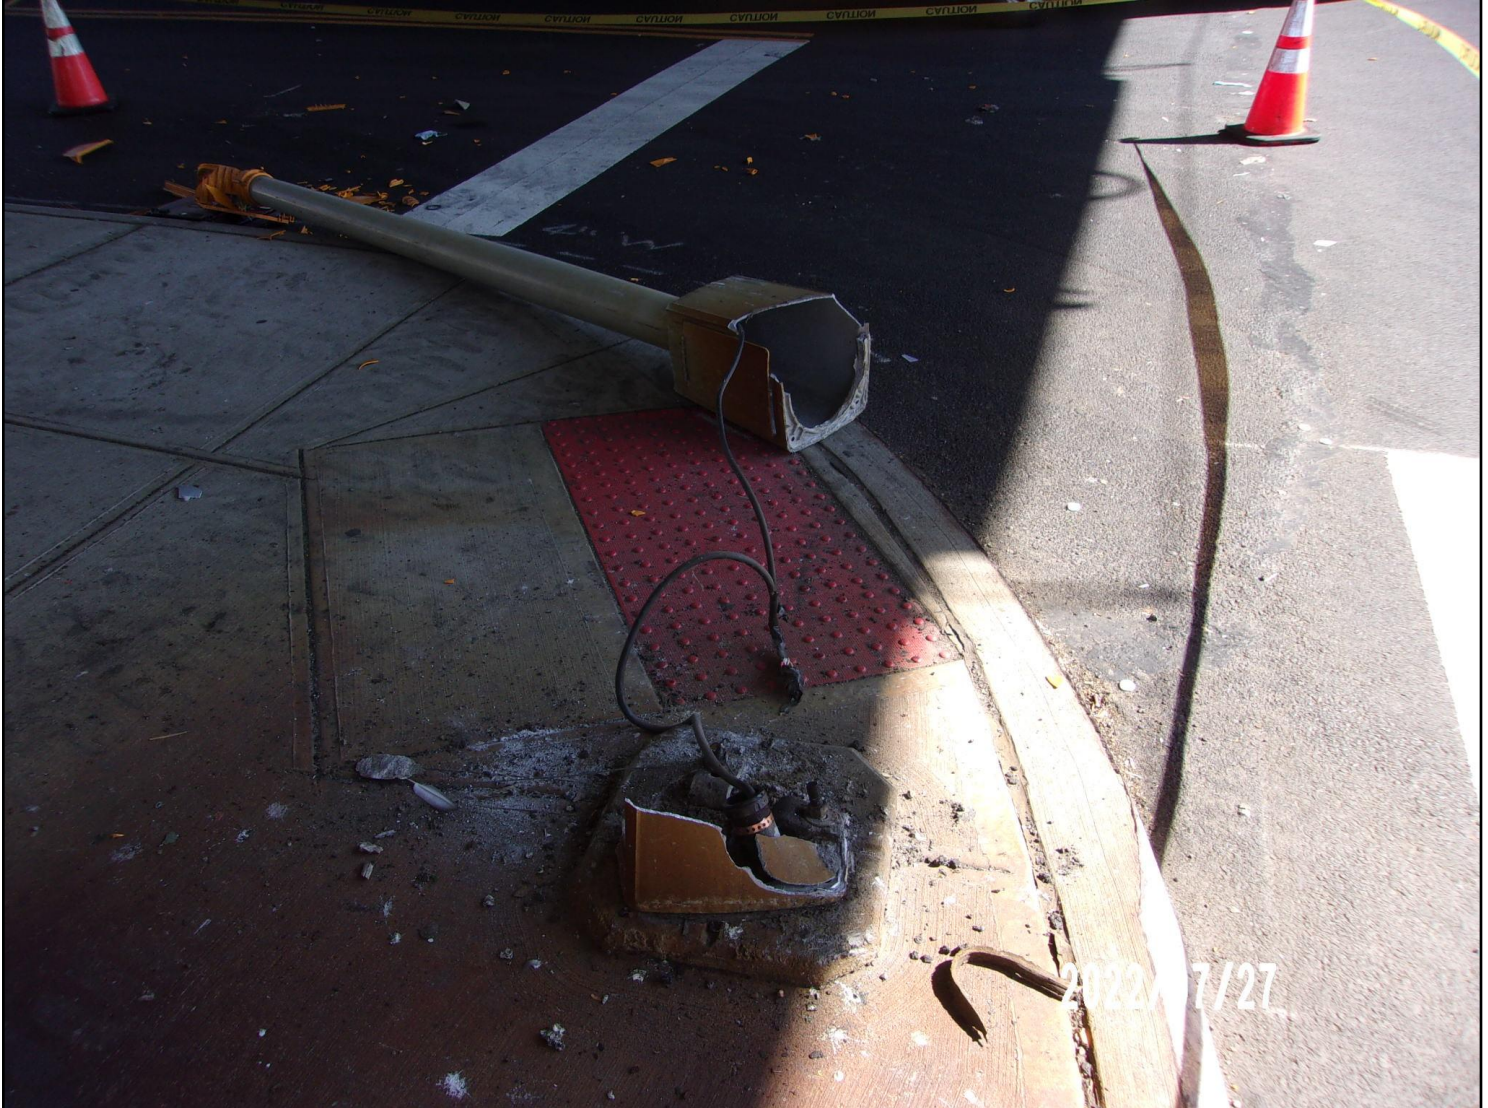
Photo Number: 5

**Attachment Description:** The sidewalk at the right end of Pier 197 under Span 198. The broken signal pole has exposed wires at the base which are accessible to pedestrians but the area has been coned off with yellow caution tape. Looking End.
